# Trip to Sunshine Coast Queensland, September 2004 Visit to Schools

## Report No 2002-059-B No 7

**Project Name** Case Based Reasoning in Construction and Infrastructure Projects

**Date:** January 2005

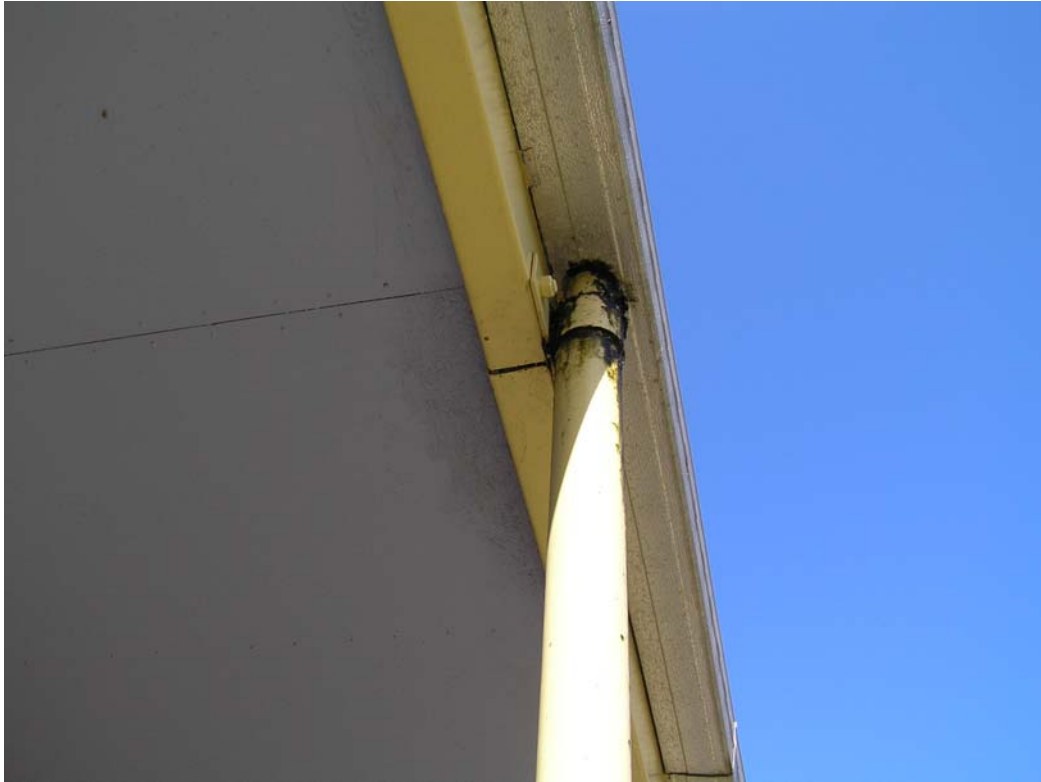
Figure 98 Structural downpipe showing that water has come through the join to the gutter and the infill panel has water damage.

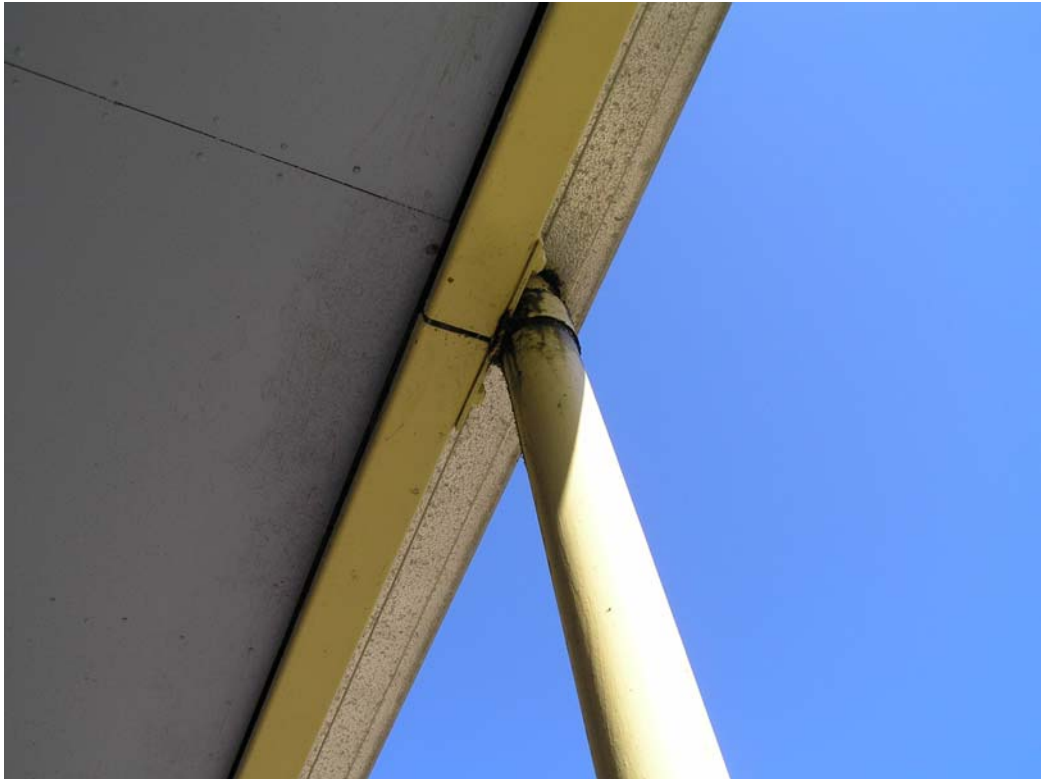
Figure 99 Structural downpipe showing that water has come through the join to the gutter and the infill panel has water damage.

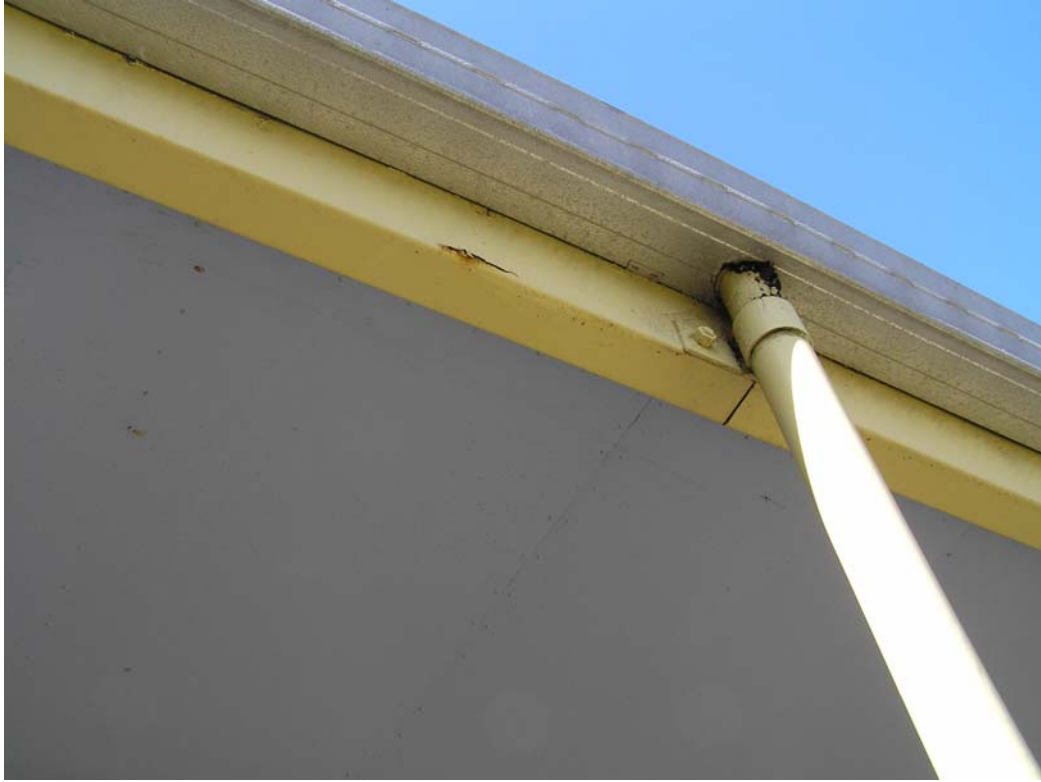
Figure 100 Structural downpipe showing that water has come through the joint to the gutter and red rust can be seen in U section.

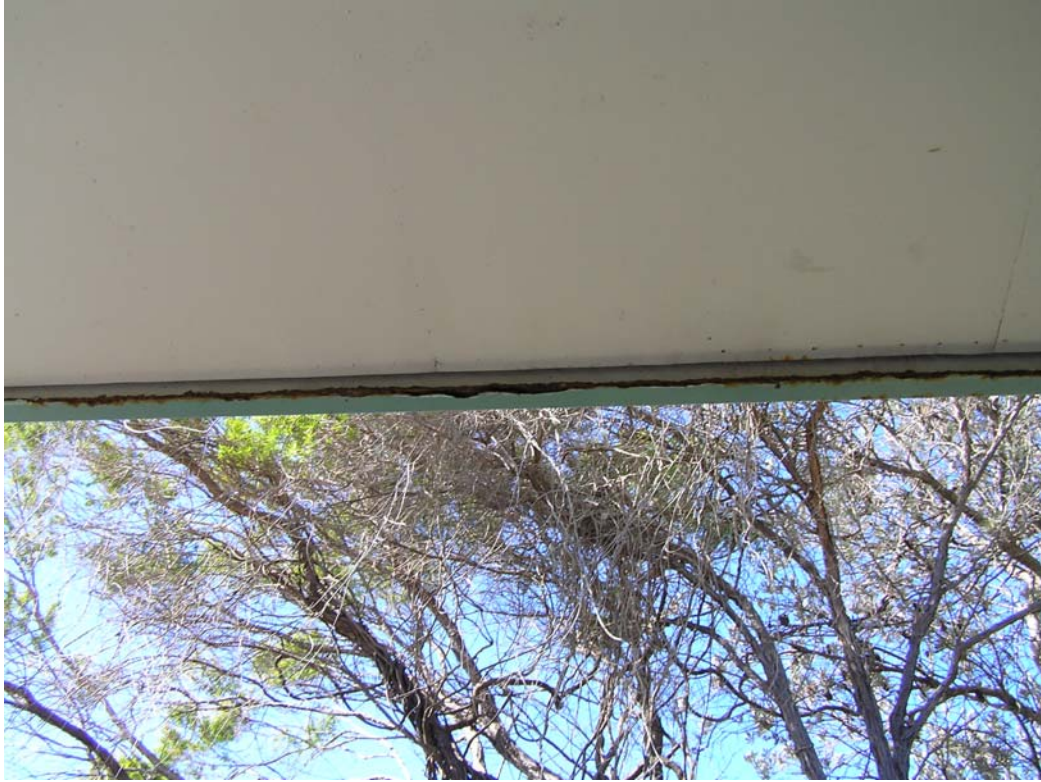
Figure 102 Looking at U section from under the eave, red rust can be seen along steel.

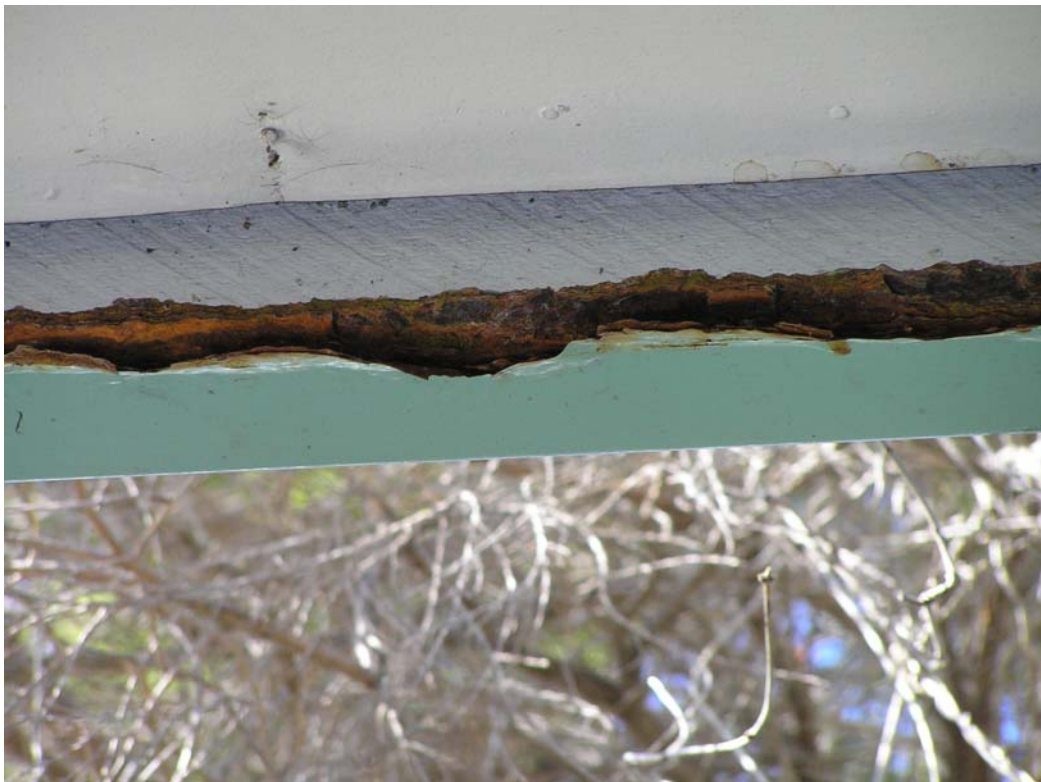
Figure 103 Close up of U section, red rust can be seen and also the wood beam which is rotting.

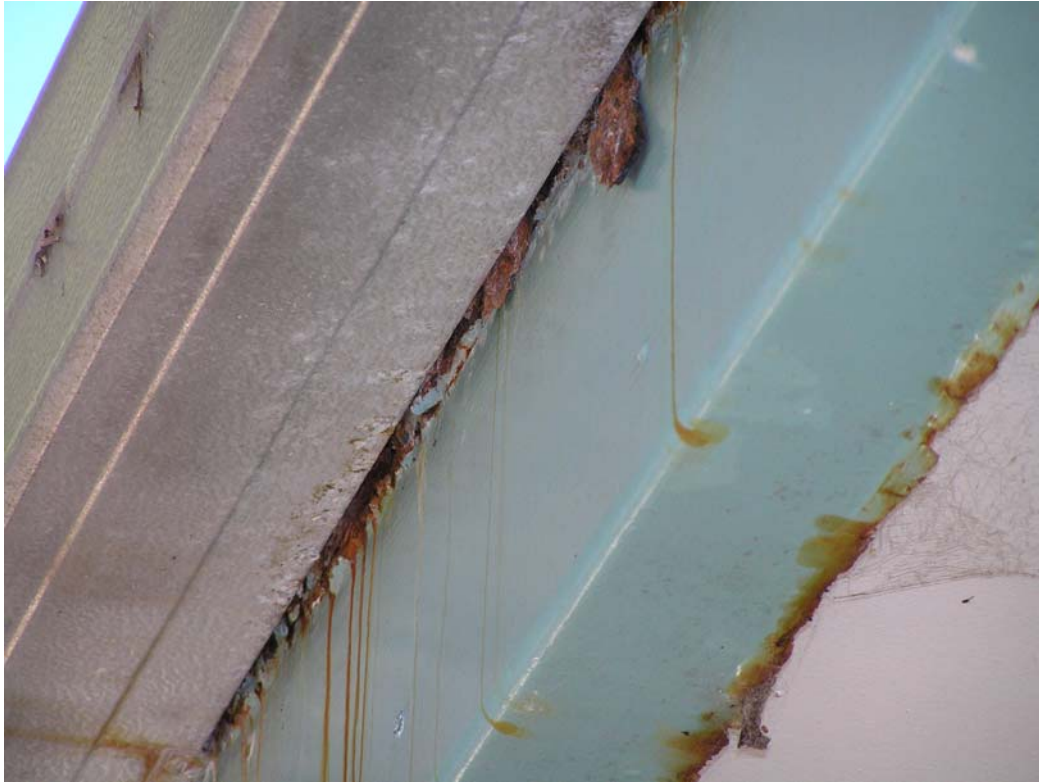
Figure 104 Close up of U section showing significant red rust.
